**Flood Control Project Maintenance  
Levee Inspections**  
**LMA District Cover Sheet**  
**Spring 2012 Levee Inspection Results**

**Reclamation District No. 1600 Mull**

**Flood Control Project Maintenance  
Levee Inspections  
Unit Cover Sheet  
Spring 2012 Levee Inspection Results  
Reclamation District No. 1600 Mull**

**Levee Inspection Report By Mile - Spring 2012**

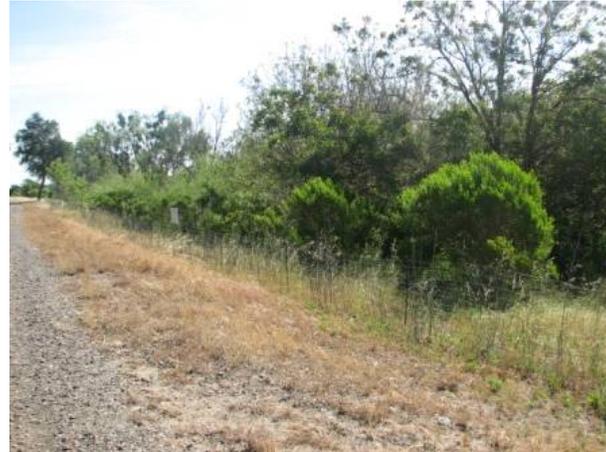
Levee Mile Report Line	16
Start Levee Mile	2.36
End Levee Mile	2.42
Location	Water Side
Category	Earthen Levee
Item	Vegetation
The revegetation site extends almost to the hinge point.	
johngw_s_20120509_821.jpg

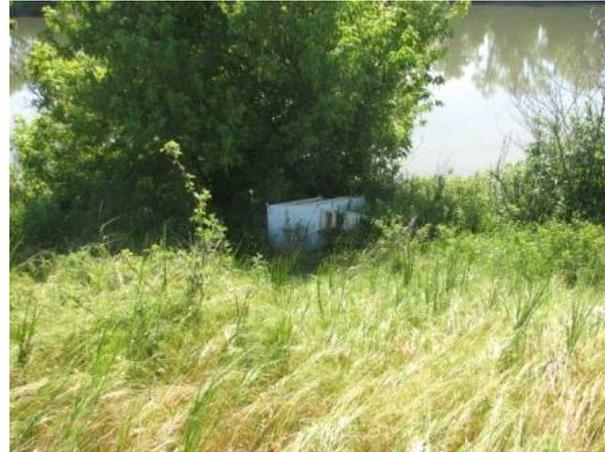
Levee Mile Report Line	21
Start Levee Mile	5.26
End Levee Mile	5.26
Location	Water Side
Category	Earthen Levee
Item	Encroachments
A refrigerator on the waterside berm. Photo taken spring 2012.	
johngw_s_20120509_822.jpg

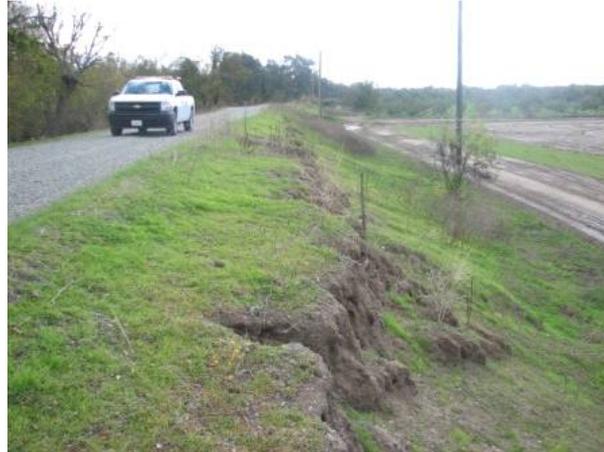
Levee Mile Report Line	32
Start Levee Mile	7.02
End Levee Mile	7.02
Location	Land Side
Category	Earthen Levee
Item	Erosion / Bank Caving
The erosion appears to be moving closer to the shoulder.	
johngw_s_20120313_474.jpg

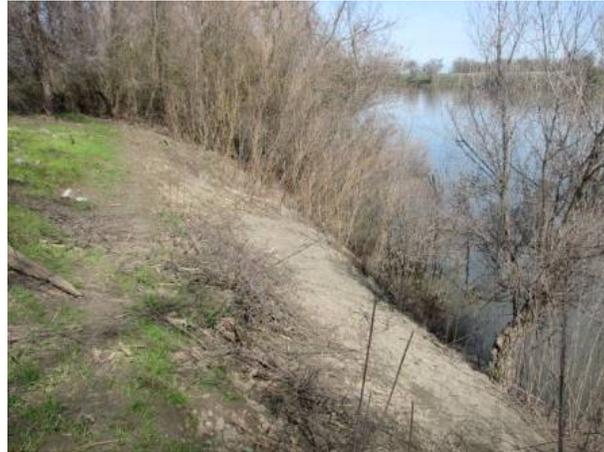
Levee Mile Report Line	34
Start Levee Mile	7.27
End Levee Mile	7.27
Location	Water Side
Category	Earthen Levee
Item	Erosion / Bank Caving
<p>The bank is eroding away and has become very steep.</p>	
<p>johngw_s_20120313_470.jpg</p>

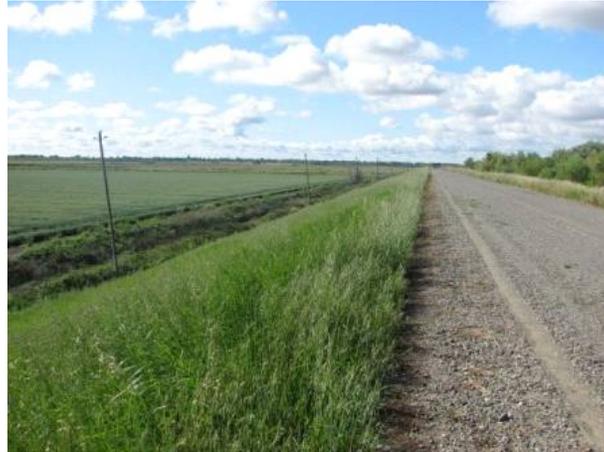
Levee Mile Report Line	1
Start Levee Mile	0.01
End Levee Mile	4.18
Location	Land Side
Category	Earthen Levee
Item	Vegetation
The grasses are taller than 12". Photo taken spring 2012.	
johngw_s_20120430_743.jpg

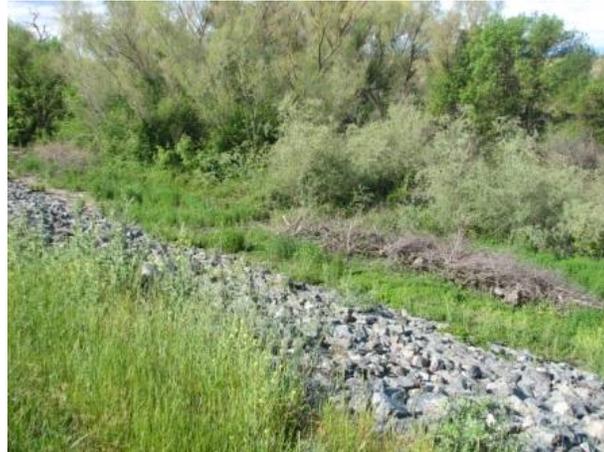
Levee Mile Report Line	4
Start Levee Mile	0.35
End Levee Mile	0.35
Location	Water Side
Category	Earthen Levee
Item	Encroachments
Pruning piles along the toe of the waterside levee. Photo taken spring 2012.	
johngw_s_20120430_745.jpg

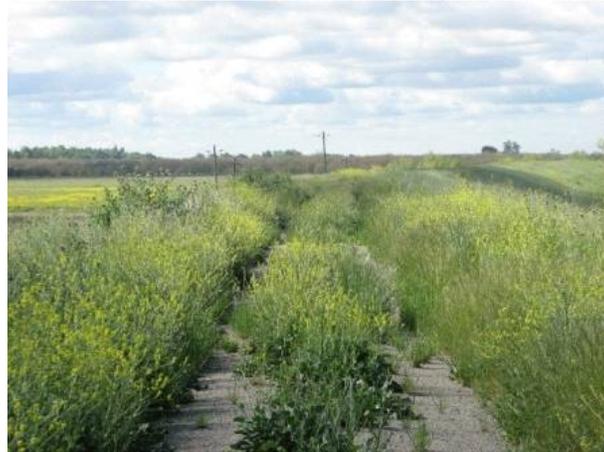
Levee Mile Report Line	7
Start Levee Mile	0.85
End Levee Mile	4.08
Location	Crown
Category	Earthen Levee
Item	Crown Surface / Depressions / Rutting
The crown roadway needs to be free of weeds. Photo taken spring 2012.	
johngw_s_20120430_747.jpg

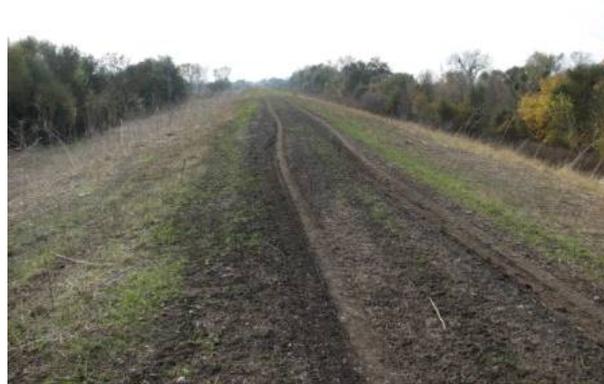
Levee Mile Report Line	11
Start Levee Mile	2.19
End Levee Mile	3.83
Location	Crown
Category	Earthen Levee
Item	Crown Surface / Depressions / Rutting
<p>The crown of the levee needs to have AB added. Some rutting has occurred.</p>	
<p>johngw_s_20120313_481.jpg</p>
